Journal of Arts & Humanities

Volume 06, Issue 03, 2017, 52-58

An Introduction to Concept and Evolution of the Guardstone and Its Architectural Visualization of the Contemporary Religious and Cultural Diversities

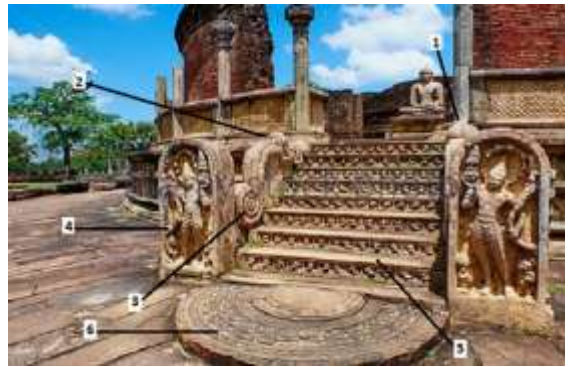
Plate 1: Line diagram depicting the placement and the associating structures of the Guardstone

1. Pot of plenty 2. Dragon structure 3. Motif of festoon extending from the dragon mouth 4. Guardstone 5. Flight of steps 6. Moonstone.

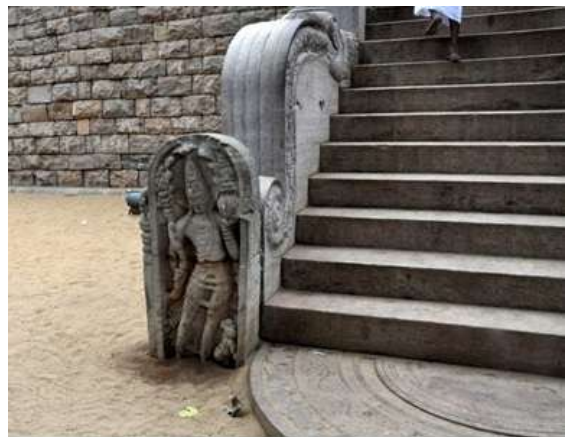
Plate 2: The tri-component assembly of an entrance.

The tri-component stony assembly which comprises of guardstone, balustrade and the moonstone associating the flight of steps at the entrance in most of the ancient buildings is a common sight whether or not they are religious in nature. Even in any particular location if a single independent guardstone is found devoid of other associating structures (except nāga image) it is reasonable to assume that it could probably be due to the decay or destruction or removal of the other two component structures.

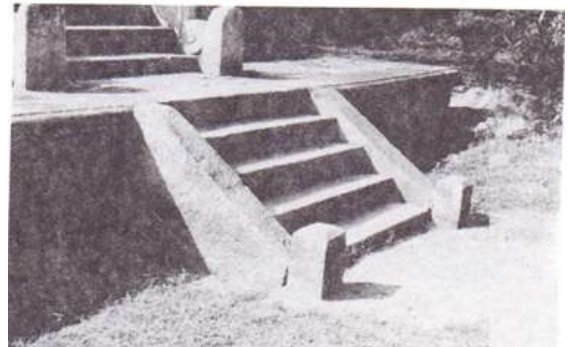
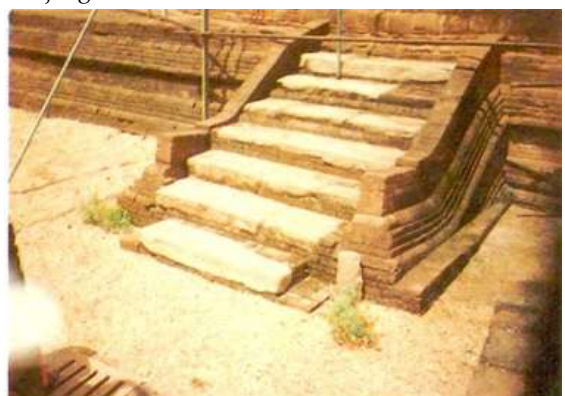
Plate 3: Guardstone at Haththi kuchchi Vihara at Rajangana

Plate 4: Entrance to the Somawathi Stupa at Polonnaruwa

At the first stage of the evolutionary process of the guardstone, it was only a square shaped slab of stone, rectangular in shape and bore no carvings. (Plates 3 and 4)

The earliest form of the guardstone is identified as a simple square shaped stone slab erected just in front of each balustrade. It contained no carvings whatsoever on it and thus believed to be the earliest form of the guardstone. Out of numerous such examples the most striking guardstone in this category is seen at *Vatadageya* in *Haththikuchchi Viharaya*, an enclosure for the stupa, situated about 5 km.s off *Galgamuwa* township on the *Maho – Anuradhapura* road.

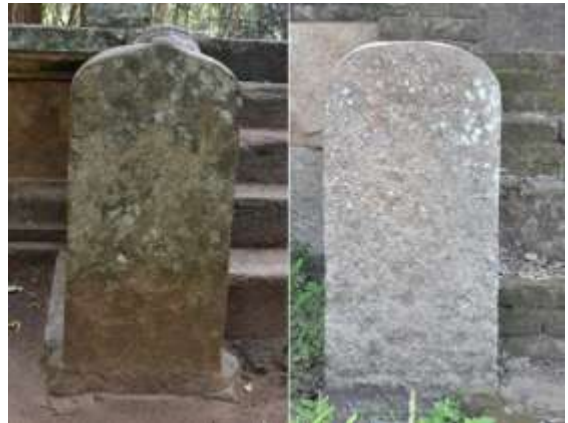
At the next stage possibly in the same century or little later, the rectangular shape became slightly curved with a small pointed hump on the upper middle of the slab. (Plate 5)

This would be the beginning of the introduction of carvings to the guardstone. Other two components of the entrance viz: moonstone and balustrade are without decorations.

Plate 5: Location – Kaparamula Entrance, and Athpokuna Entrance, Anuradhapura

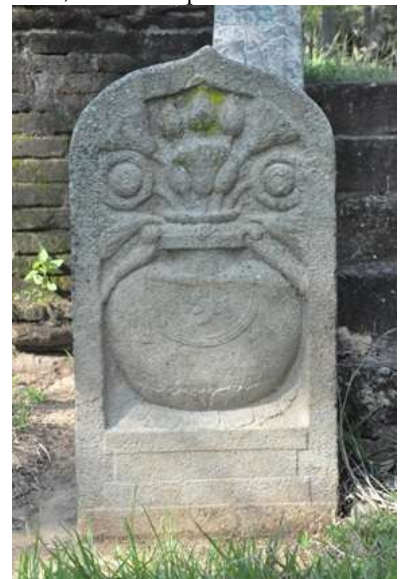
At the next stage the pot of plenty was introduced. In the Sri – Lankan cultural context the pot of plenty is considered as a symbol of prosperity and abundance, the first eye – contact a welcome omen at an entrance.

These guardstones seem to have been incised very lightly and in later stages in high relief. Most of these pots are filled with coconut fronds or with lotus flowers which again characterize those as symbols of prosperity and wealth

Plate 6: Guardstones at Uththaramula Entrance, Anuradhapura

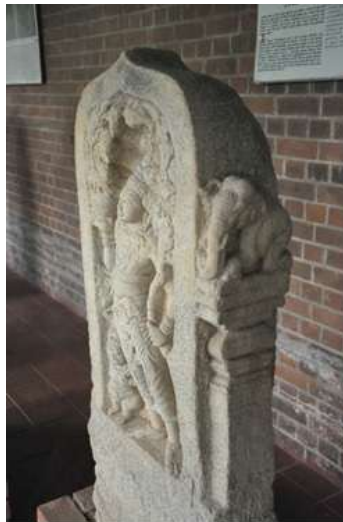
Plate 9: Elephant symbol on a guardstone

To distinguish the four directions on the guardstones, sculptures adapted four animal symbols on to them, namely elephant, bull, horse, and lion to depict the East, South, West and North respectively. The use of these animal symbols according to the directions is a concept familiar to Sri Lanka Buddhism.

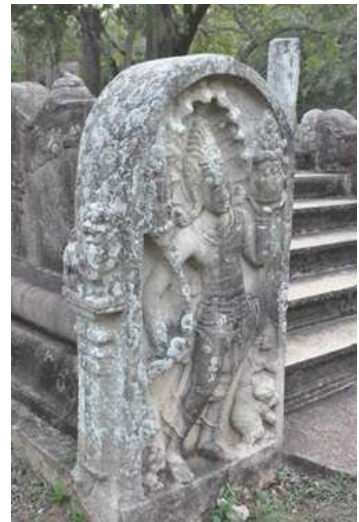
Plate 10: Lion symbol on a guardstone

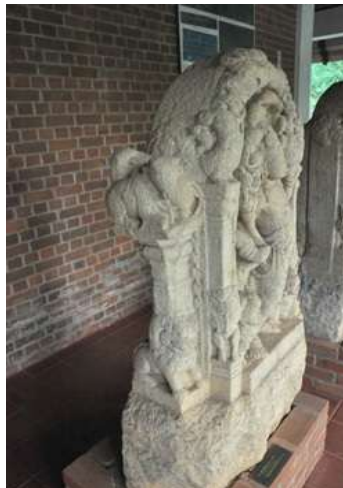
Plate 101: Bull symbol on a guardstone

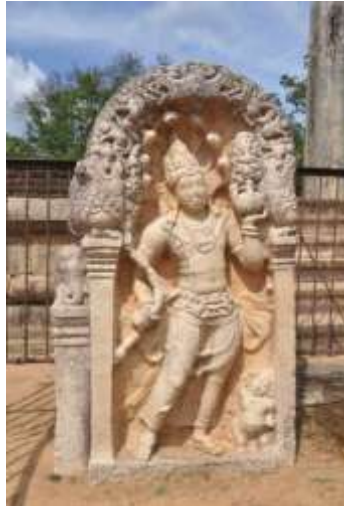
The most sophisticated creation in the records of the guardstone is seen at *Ratnaprāsādaya*, *Polonnaruwa*. This recognition to the guardstone at *Rathnaprāsādaya* is no doubt owes to the complexity of many delicate carvings that adorns the Nāga Raja image. Apart from the 'tribanga' posture of the Naga Raja image

the upper part of the guardstone is decorated with a dragon arch with three dragon heads: One in the middle and the other two at the two bases of the arch. From the two sides of the dragon mouth a lion is thrown out from each side along with a dancing couple whose destiny is to fall into the dragon mouth below. A set of seven cobra heads adorn the Nagaraja Head and an elephant head as well as a dwarf image at each foot base respectively. The above symbolic inclusions which possess meticulous

This is the most artistic guard stone found in Sri Lanka. Two lovers emerge from the dragon's mouth above the cobra king, who has in his hand the pot of abundance signifying prosperity. This is said to show that fertility generates prosperity. Indulgence in worldly life is like entering the mouth of a dragon is another interpretation. It belongs to the 7-9 century AD.

Plate 11: Guard stone at Rathna prasadaya, Abhayagiriya

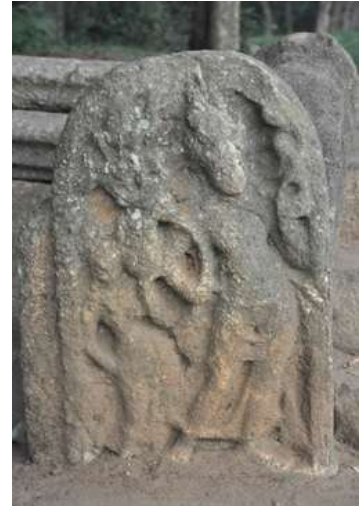
There are also some guardstones which depict the wife of that incumbent Nāgaraja but in a smaller scale than the nāgaraja figure. The guardstone at the Eastern part of the Mahasen palace depict an image of a woman believed to be god *Dratharashtra's* Queen – wife. The different dimensions of the two images can be attributed to the principle of patriarchy.

Plate 12: Nagaraja Dratharashtra and his wife
